Service Manual

8065752478 Rev. A, CATALOG NO.

Centurion® Vision System Service Manual
8065752478

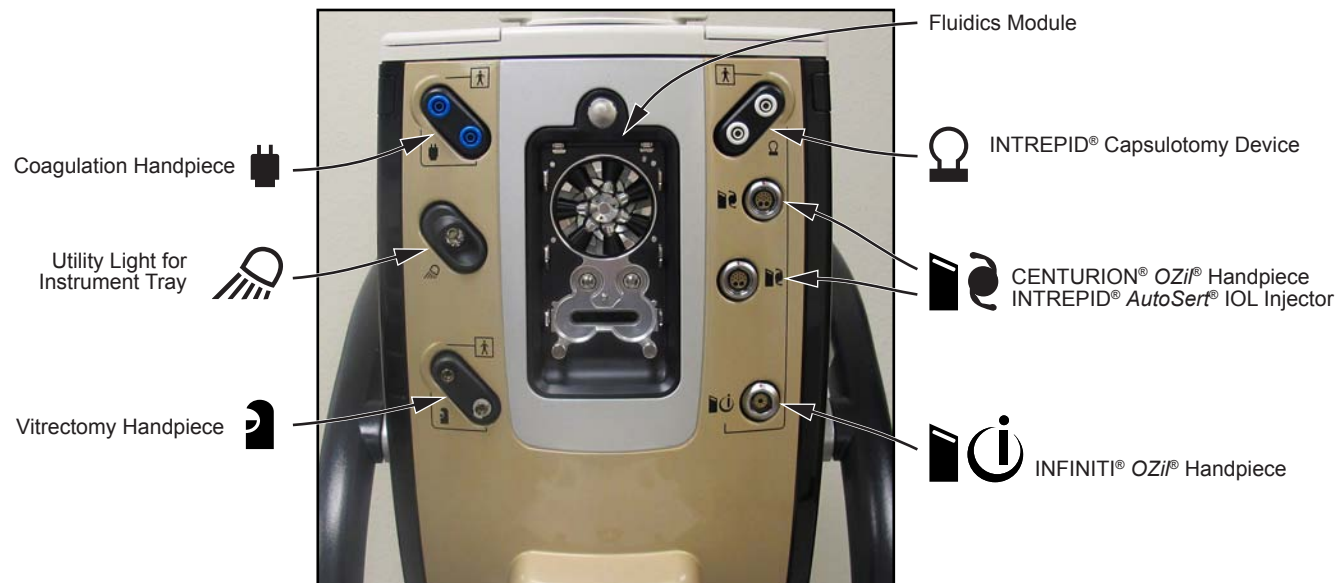
Figure 1-2 Front Panel Connectors

The front panel connectors are located on both sides of the fluidics module. The front panel connectors provide three self-locking phaco handpiece connectors, two connectors for the INTREPID® AutoSert® IOL Injector, one connector for a bipolar coagulation handpiece, connectors for the INTREPID® Capsulotomy Device, and luer lock pneumatic connectors for the *Centurion®* UltraVit® Probe. The left row of connectors also includes a utility light for the instrument tray. Symbols near the connectors facilitate handpiece identification.

The Centurion® OZil® handpiece is recognized in the top two phaco handpiece connectors; only the INFINITI® OZil® handpiece is recognized in the bottom. Only one phaco handpiece can be connected at one time in either connector, unless the UltraChop feature is enabled in which case the system will accept two phaco handpieces.

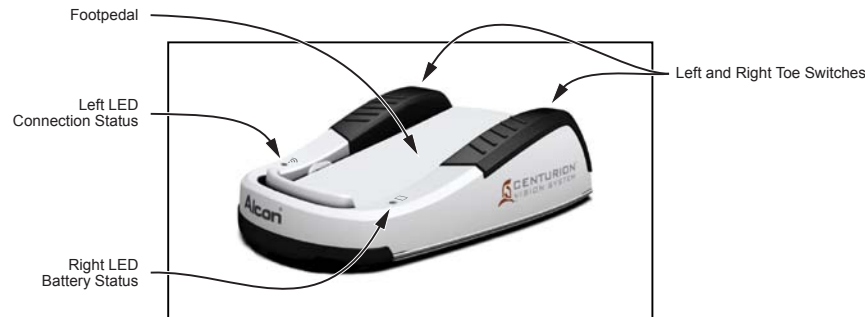
Figure 1-5 The *Centurion®* Footswitch

The *Centurion®* footswitch, shown in Figure 1-5, can be used wirelessly or can be wired to the console. When the footswitch is operated wirelessly, it retains the same functionality as it does when it is wired to the system. The wireless footswitch is immune to interference from other wireless devices.

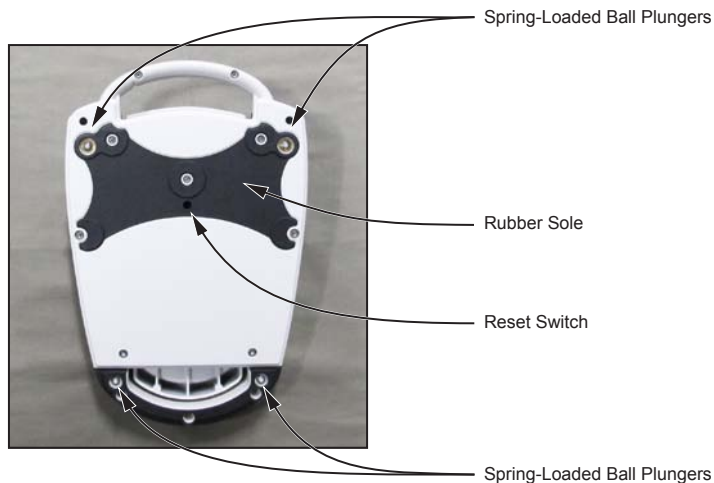
Figure 1-6 Bottom of Centurion® System Footswitch

The footswitch has four spring-loaded ball plungers at each corner of the bottom plate (see Figure 1-6). These ball plungers are designed to allow easy sliding of the footswitch on a smooth floor, and yet still offer secure floor gription when the weight of the surgeon's foot is resting upon it.

The weight of the surgeon's foot on the footswitch causes the spring-loaded ball plungers to collapse, allowing the footswitch to rest on its rubber sole, thus preventing it from sliding on the floor. The tension of the spring-loaded ball plungers is adjustable to the surgeon's preference using a wide, flat-tip screwdriver. Simply place the screwdriver directly on top of the ball and press down until the screwdriver tip settles into the screw slot, then turn clockwise or counterclockwise to increase or decrease the spring tension.

A power reset switch is located in the bottom of the footswitch. In the case that a reset is required, simply press a cotton swab into the small hole in the bottom to depress the switch and turn power back on (see Figure 1-6). Re-pairing of the footswitch will restore the previously-programmed footswitch settings.

- 2.2 Set the footswitch to “shipping” mode by pressing the switch shown in Figure 1-6 with a cotton swab or other instrument that can reach the recessed switch without damaging the rubber covering.

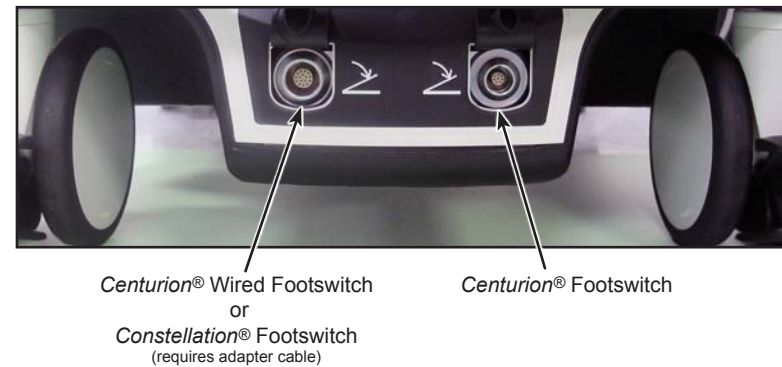
Figure 1-7 Footswitch Connector Panel

The Centurion® footswitch can be wired to the system, while the Centurion® Wired and Constellation® footswitches must be wired. Figure 1-7 shows the footswitch connector panel located at the bottom-front of the system.

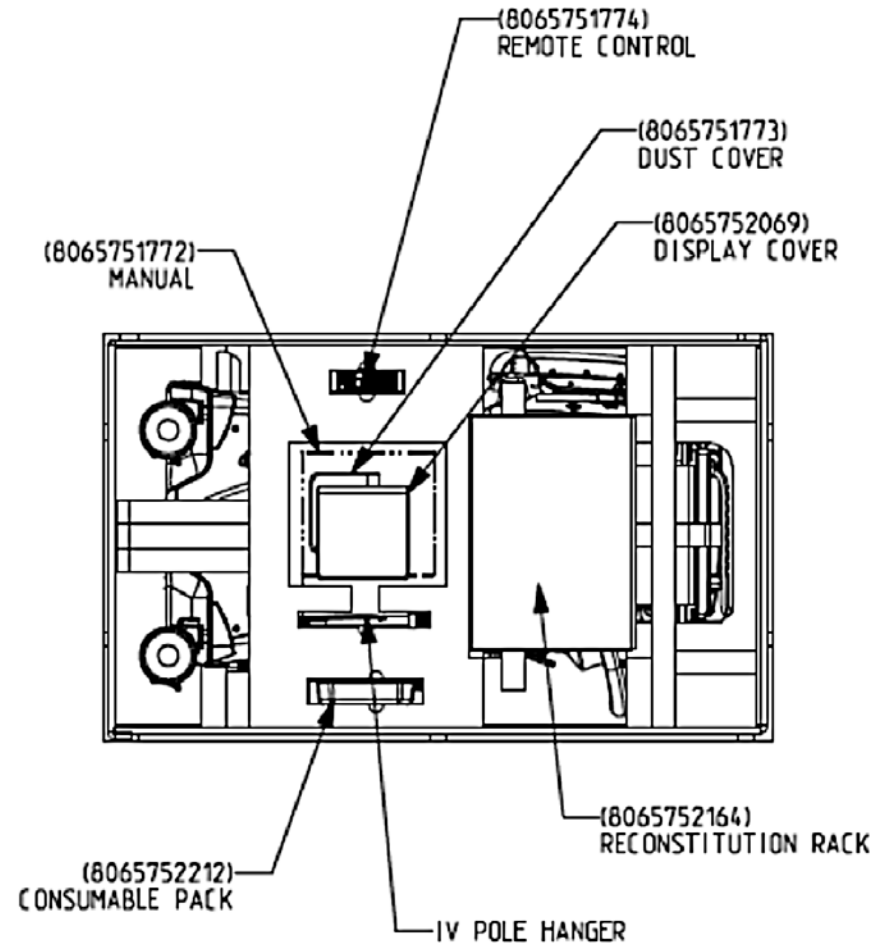
Figure 1-12 Packing Configuration

- 1.1.1 Cut the packing straps and then remove the top cover. Refer to Figure 1-12 for packing configuration.
- 1.1.2 Remove all the accessories and set aside; (operator's manual, dust cover, display cover, remote control, IV pole hanger, cassette pack and reconstitution BSS bag rack)

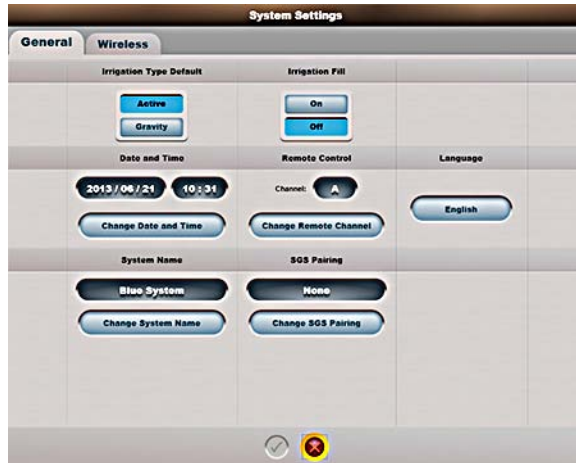
Figure 1-13 System Settings - General Tab for Setting Date and Time

- 1.4.1 Plug console into power outlet and turn on.
- 1.4.2 Navigate to |System Settings|General| to set the Date & Time (see Figure 1-13).

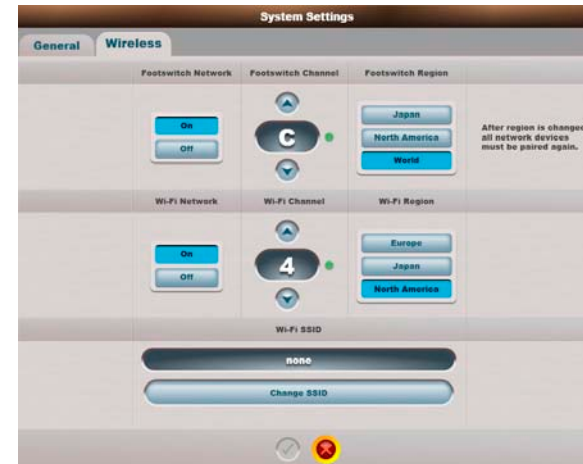
Figure 1-14 System Settings - Wireless Tab for Footswitch Setup

- 1.4.3 Within the |System Settings|General| tab you can also input a System Name, this is optional and can be done by the user. This name will be displayed in the upper right section of the Backup/Restore dialog screen.
- 1.4.4 Navigate to |System Settings|Wireless| to setup the wireless footswitch and, if needed, Wi-Fi settings (see Figure 1-14).

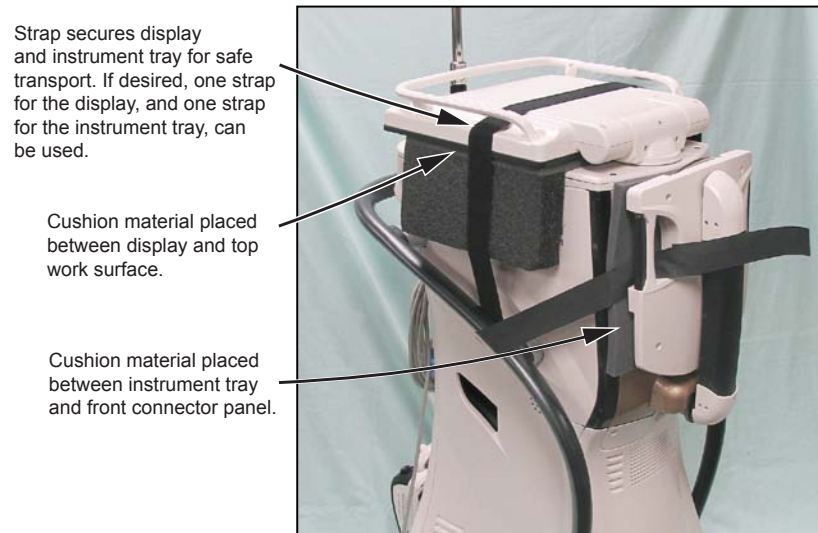
Figure 1-15 Example of Properly Packing the System for Transit

- 2.1 Using the photo shown in Figure 1-15 as an example, secure the display screen and instrument tray as necessary in preparation for transit. **NOTE: Materials from the original shipping container are used in this example.**

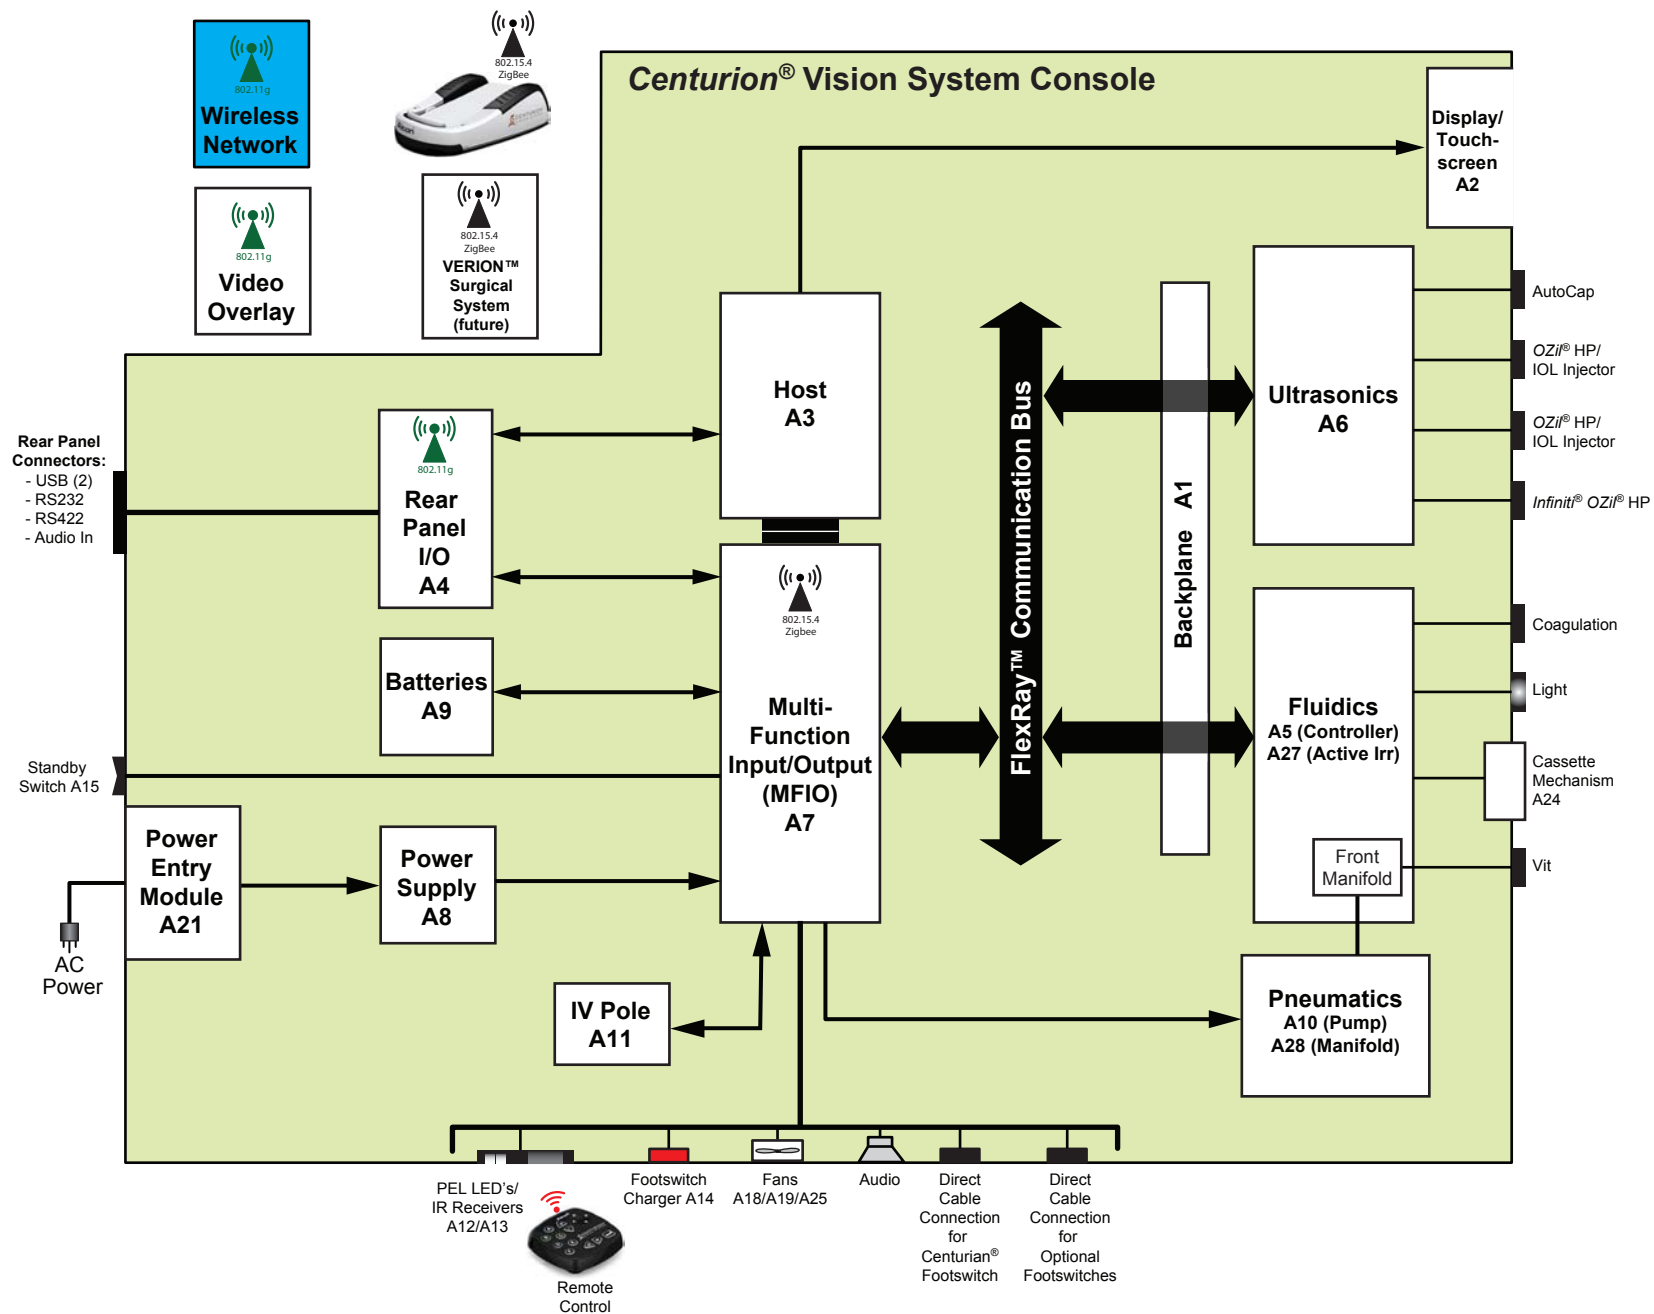
Figure 2-1 System Block Diagram

The *Centurion®* Vision System is a software-driven electromechanical device designed to delivery state-of-the-art performance for all aspects of cataract lens extraction. Figure 2-1 shows a block diagram of the system. A general description of the diagram follows.

The MFIO PCBA functions as a system backplane, distributes the main 24 VDC supply and FlexRay™ communication buses, as well as providing the electronics and software needed to control or interface with a number of modules shown in Figure 2-1 and listed below:

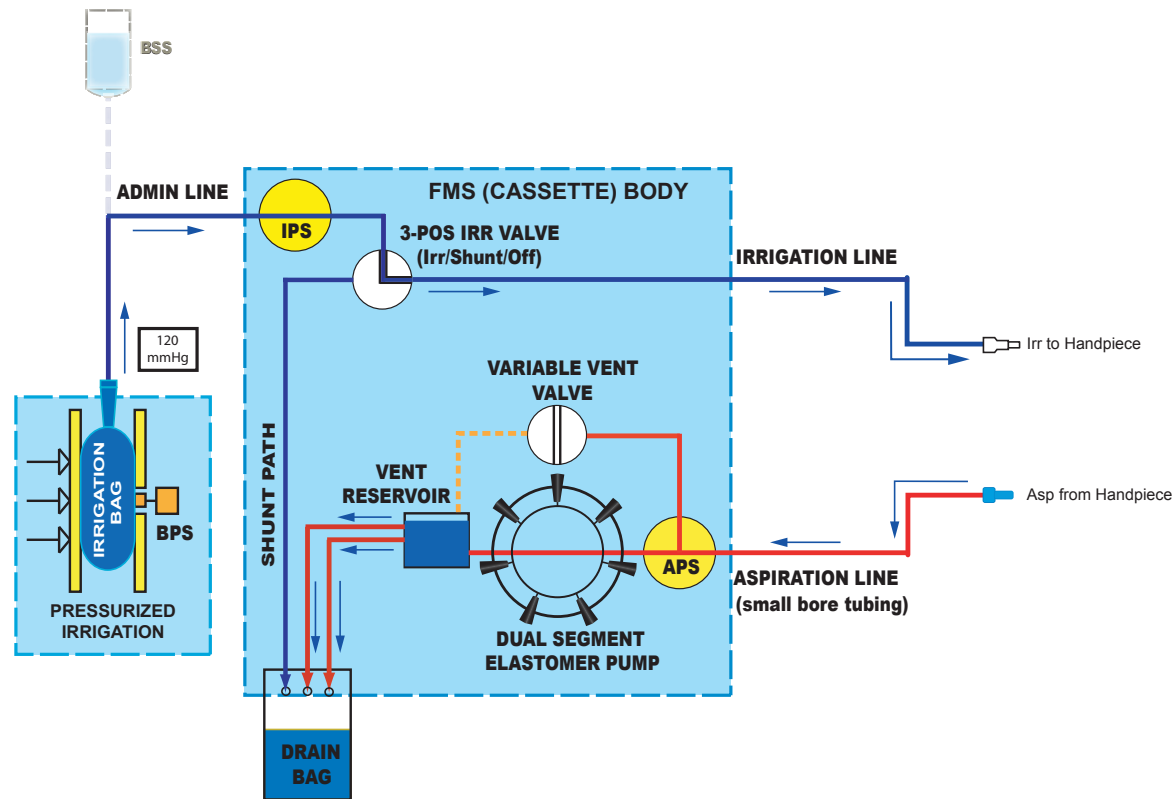
Figure 2-2 Fluidics Fluid Flow Diagram

The main function of the Fluidics system is to provide irrigation (active or gravity) and aspiration to the surgical site during a cataract removal procedure. Pressure sensors enable the system to detect an overpressure or underpressure condition relative to a surgeon-selected IOP target setting. Additional control features are provided to allow adjustment to the level of flow compensation based on the surgeon's observations of the anterior chamber fluctuations. This provides flexibility to customize the system to accommodate for differences in surgical technique, incision size, tip/sleeve selection, or surgeon preference. Figure 2-2 shows a diagram of the fluid flow in the fluidics system.

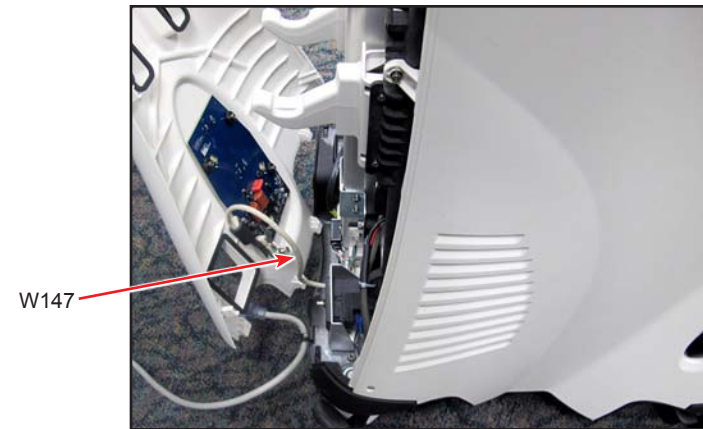
Figure 3-3 Cable W147 connecting Footswitch Charging PCB to MFIO PCBA

The Footswitch Charging PCB is mounted the Lower Rear Panel and is connected to the console (MFIO PCB) by W147 (see Figure 3-3). After removal, panel can be laid flat on floor without disconnecting cable.

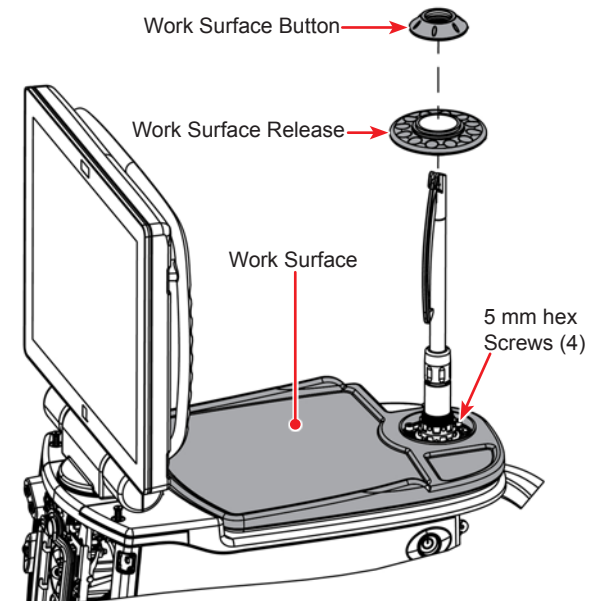
Figure 3-5 Removal of Work Surface Button and Release Button

- 8.1 Unscrew and remove Work Surface button (see Figure 3-5).

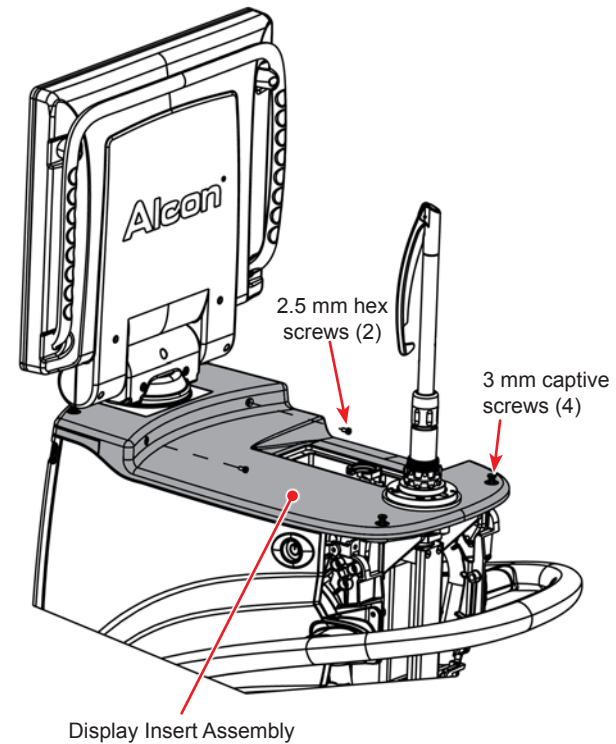
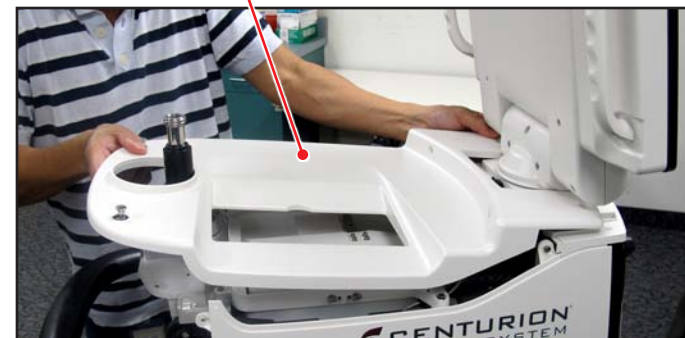
Figure 3-6 Removal of Display Insert Assembly

- 9.1 Remove Work Surface.
- 9.2 Loosen four 3 mm captive hex screws securing Display Insert to console (see Figure 3-6). Reposition Display as necessary to access screws.

- 9.3 Loosen and remove two 2.5 mm hex screws securing Display Insert to console.
- 9.4 Grasp one side of the front part of the Display Insert (near display) and the back of the panel (near the IV Pole), then lift the panel up and back until both parts of the panel have cleared the “lip” of the chassis underneath the Display Insert Panel (see photo in Figure 3-6). Leave Display Insert in this position.

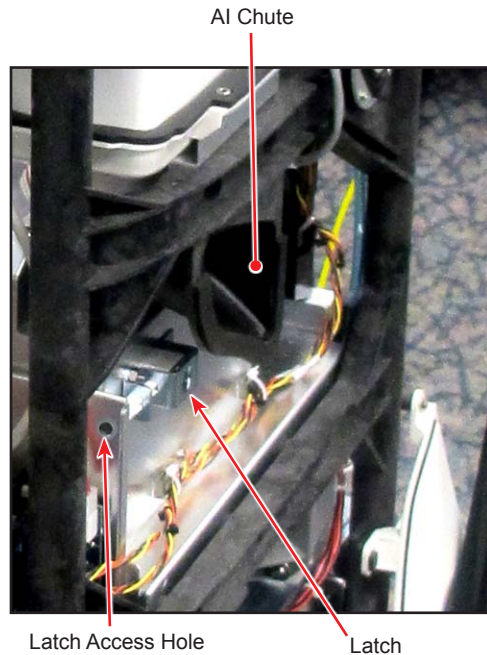
Figure 3-7 Lower Right Panel Latch Release (shown with panel removed)

- 13.1 Remove Upper and Lower Rear panels.
- 13.2 Remove Upper Right panel.
- 13.3 Remove six 3 mm hex screws and washers securing Lower Left Panel to console.
- 13.4 The panel is now held in place by a latch mechanism located just below the AI Chute in the console. The latch release is accessed from the rear through a hole in the sheet metal bracket that the MFIO PCB is mounted on (see Figure 3-7).

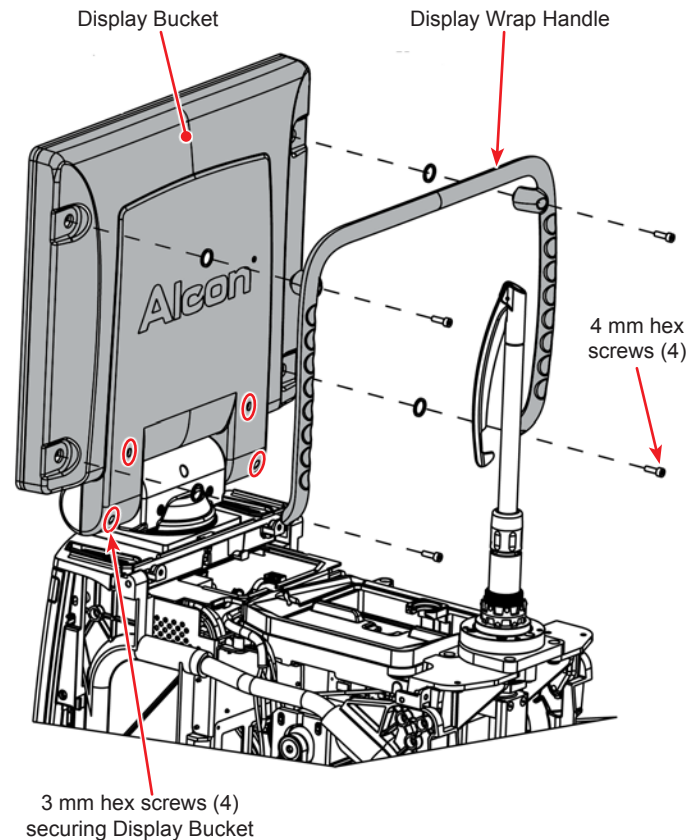
Figure 3-8 Display Wrap Handle and Display Bucket Removal

- 16.1 Remove four 4 mm screws securing Display Wrap Handle to display assembly. Remove Display Wrap Handle from system (see Figure 3-8).

- 16.2 Remove four 3 mm hex screws securing Display Bucket to display assembly. Remove Display Bucket from system.

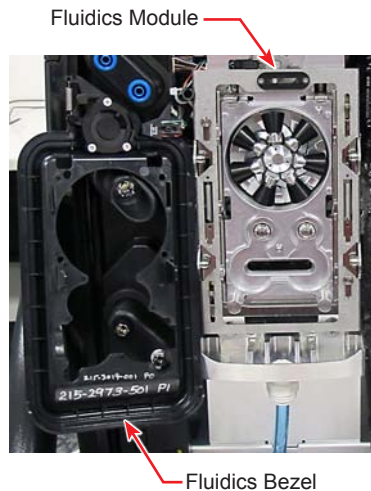
Figure 3-9 Fluidics Module with Bezel Removed

- 17.1 Remove Front Vent and Upper Front Panels.
- 17.2 Remove black Fluidics Bezel by pulling it straight out from Fluidics Module. Bezel is attached to module by cable – allow bezel to hang freely in front of Fluidics Module during remainder of procedure (see Figure 3-9).

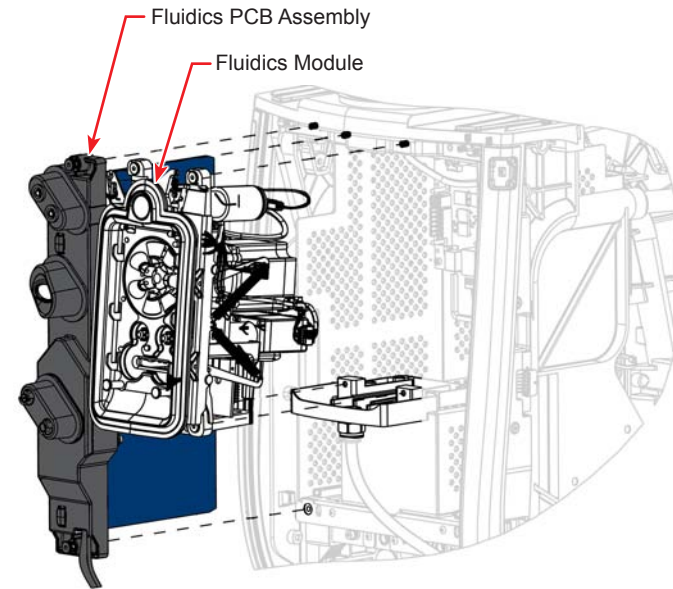
Figure 3-10 Fluidics Module and Fluidics PCB Assembly Removal

- 17.3 Loosen four 3 mm captive hex screws securing top and bottom of Fluidics Module to chassis (see Figure 3-10).
- 17.4 Loosen two 3 mm captive hex screws securing Fluidics PCB Assembly to chassis.
- 17.5 Disconnect yellow and blue pneumatic tubing from Pneumatic manifold (see Figure 3-16).

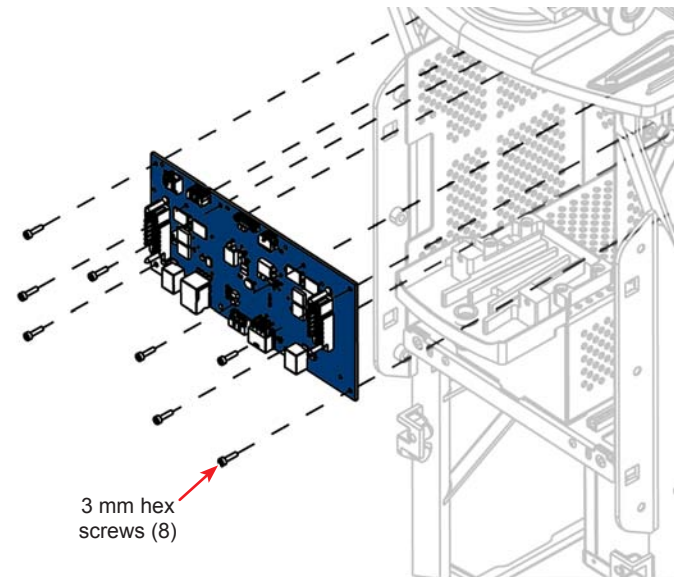
Figure 3-12 Upper Backplane PCB Removal

- 19.1 Remove Front Vent and Upper Front Panels.
- 19.2 Remove Fluidics Mechanism, Fluidics PCB, and U/S PCB Assemblies.
- 19.3 Disconnect J12, J16, J10 (may require screwdriver), J11, J4, J3, and J9 from Upper Backplane PCB.
- 19.4 Remove eight 2.5 mm hex screws securing Upper Backplane PCB to console.
- 19.5 Carefully pull Upper Backplane PCB off guide posts, rotate to clear display cables, and remove from system (Figure 3-12).

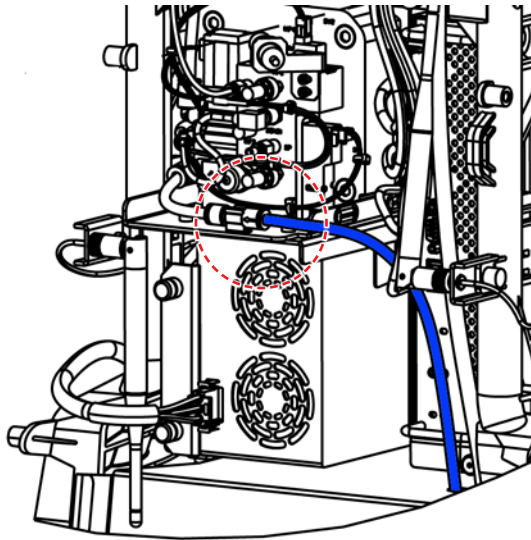
Figure 3-15 Pneumatic Tubing Connecting Pneumatic Manifold and Vit Pump

- 22.1 Remove Front Vent, Upper and Lower Front Panels.
- 22.2 Disconnect blue tubing between Pneumatic Manifold and Vit Pump (see Figure 3-15).
- 22.3 Disconnect yellow and blue tubing between Pneumatic Manifold and Fluidics PCB Assembly (see Figure 3-16).
- 22.4 Disconnect cable W133 connectors from Pneumatic Manifold (includes A28SENS1).
- 22.5 Loosen two 3 mm captive hex screws securing Pneumatic Manifold to chassis (see Figure 3-17).
- 22.6 Slide Pneumatic Manifold forward and remove from console.

- 24.1 Remove Front Vent, Upper and Lower Front Panels.
- 24.2 Disconnect J10B (W164), J1A (W112), J1B (W126), J2 (W104), and J3 (W103) from Host Module.
- 24.3 Disconnect blue tubing from Pneumatic Manifold (provides clearance to remove Host module - see Figure 3-15).
- 24.4 Remove antenna by unscrewing plastic nut (provides clearance to remove Host module).
- 24.5 Loosen two 2.5 mm captive screws securing Host Module to chassis (see Figure 3-19).
- 24.6 Pull Host Module forward while repositioning pneumatic tubing and cables to provide clearance for module removal. Remove Host Module from console.
REPLACEMENT: Carefully slide Host Module into console until it engages connector and is properly seated in place.

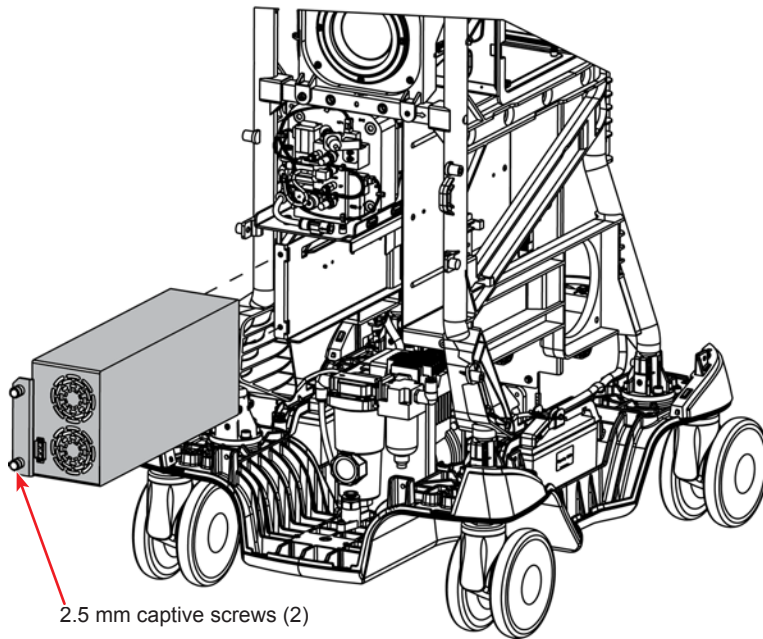
Figure 3-18 Power Supply Removal

- 23.1 Remove Front Vent, Upper and Lower Front Panels.
- 23.2 Disconnect W111 P1 from Power Supply.
REPLACEMENT: Antenna should be pointing down with Power Supply cable routed around it.
- 23.3 Loosen two 2.5 mm captive hex screws securing Power Supply to chassis (see Figure 3-18).
- 23.4 Slide Power Supply forward, adjusting position as necessary to clear antenna, and remove from console.

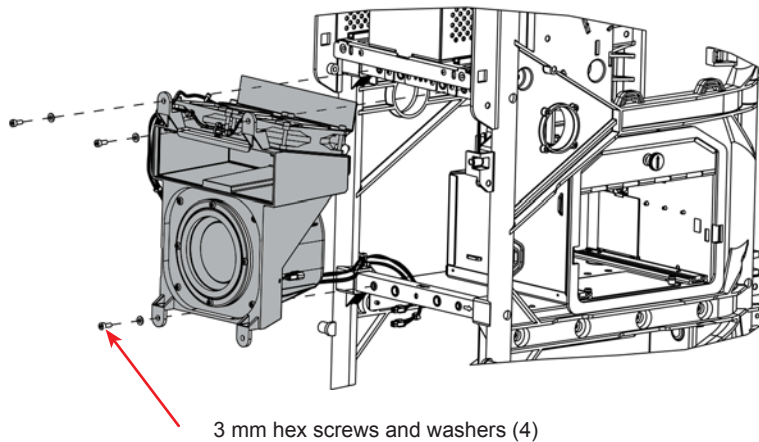
Figure 3-20 Filter/Subwoofer Box Removal

- 25.1 Remove Front Vent, Upper and Lower Front Panels.
- 25.2 Disconnect J1 from Sub-woofer.
- 25.3 Disconnect J18 and J35 from MFIO PCB.
- 25.4 Cut tie wraps securing W129-1 and W129-2 to chassis.
- 25.5 Remove four 3 mm hex screws and washer securing Sub-woofer/fan assembly to chassis (see Figure 3-20).
- 25.6 Carefully pull Filter/Subwoofer Box forward to remove from system.
- 25.7 FAN REMOVAL
 - 25.7.1 To remove fans from assembly, remove four 3 mm hex screws securing bracket to assembly.
 - 25.7.2 Remove two 3 mm hex screws securing front of fans to assembly. Cut tie wraps as necessary and remove fan(s).

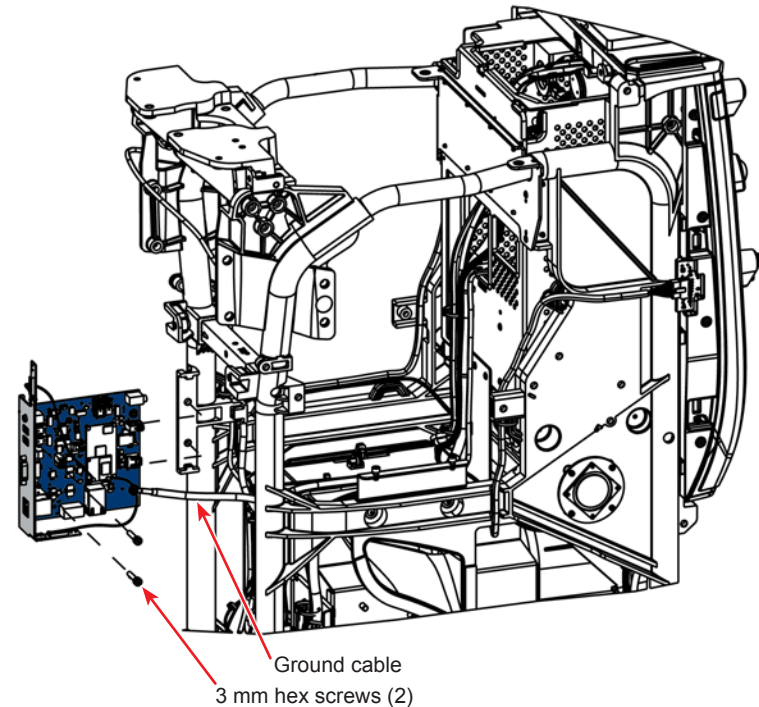
Figure 3-21 Wireless Module Removal

- 26.1 Remove Upper Rear, Lower Rear, and Upper Left Panels.
- 26.2 Remove 40 A fuse from MFIO PCB (in case hardware is dropped).
- 26.3 Disconnect J4, J5, J7, and J10 from Wireless PCB.
- 26.4 Remove 2.5 mm hex screw and star washer securing ground terminal lug to Wireless PCB.
- REPLACEMENT ORDER:* From PCB – star washer/terminal lug/hex screw
- 26.5 Remove two 3 mm hex screws securing Wireless Module to chassis (see Figure 3-21). Screws are accessed from inside chassis; removal of lower right panel may be necessary.
- 26.6 Slide Wireless Module straight back and out of console.

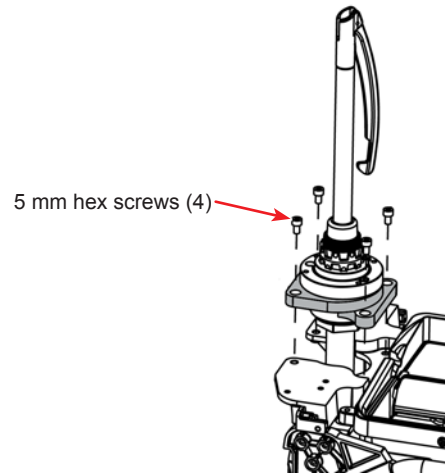
Figure 3-22 Work Surface Hub Removal

- 27.1 Remove Work Surface and Display Insert Assembly.
- 27.2 Remove Upper and Lower Rear Panels.
- 27.3 Remove four 5 mm hex screws securing work surface hub at top of IV Pole Assembly to chassis. Slide hub up and remove from IV Pole Assembly (see Figure 3-22).

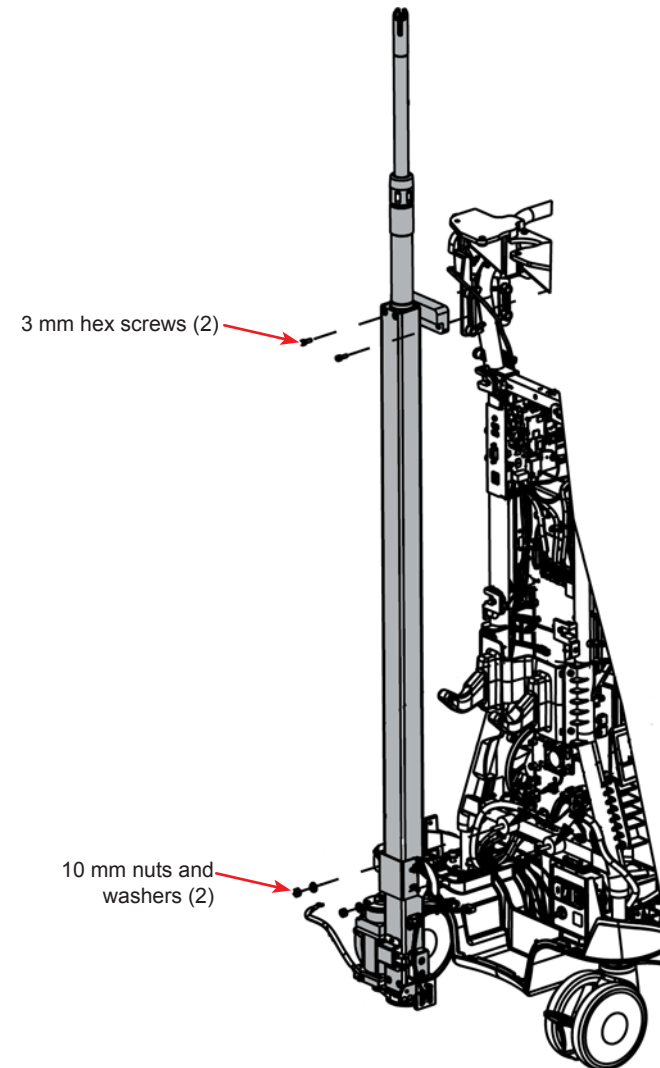
Figure 3-23 IV Pole Assembly Removal

- 27.4 Remove two 3 mm hex screws securing inside top of IV Pole Assembly to chassis (see Figure 3-23).
- 27.5 Loosen two 10 mm nuts and washers securing bottom of IV Pole Assembly to standoffs on chassis. Nut do not need to be completely removed (see Figure 3-23).

REPLACEMENT: Do not tighten nuts until two 3 mm hex screws at inside top of assembly are in place.

- 27.6 Disconnect J5 and J23 from bottom of MFIO PCB.
- 27.7 Remove 3 mm hex screw securing ground terminal lug to IV Pole Assembly.
- 27.8 Lift IV Pole Assembly upward until there is enough clearance to remove assembly from console.

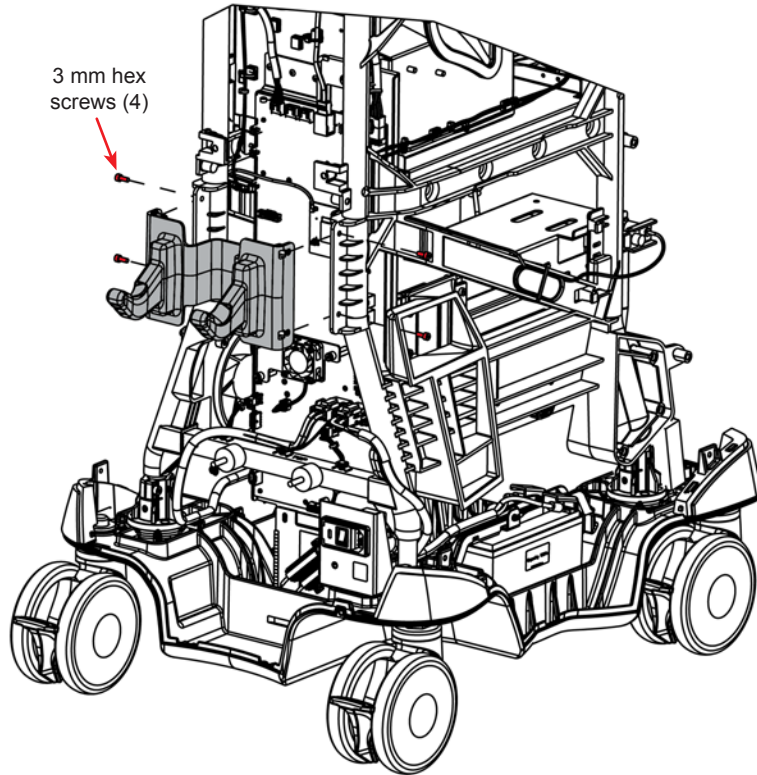
Figure 3-24 Footswitch Hook Removal (shown with IV Pole removed)

- 28.1 Remove Upper and Lower Rear Panels.
- 28.2 Remove four 3 mm hex screws securing footswitch hanger to chassis (see Figure 3-24).
- 28.3 Slide Footswitch Hook up to provide clearance then rotate around IV Pole and remove from console.

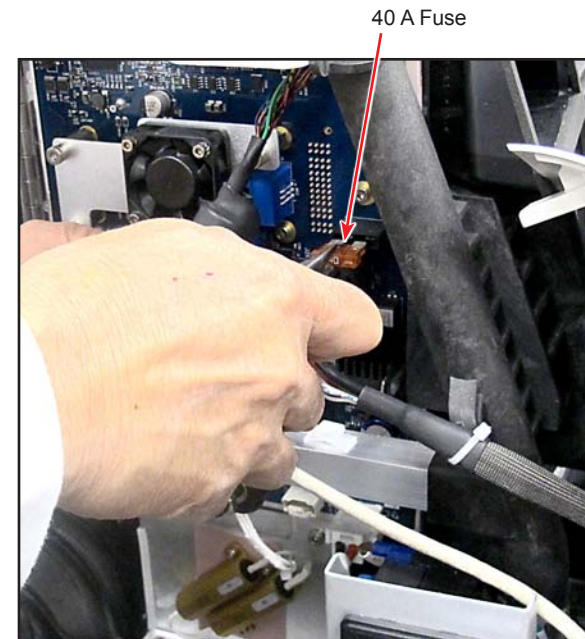
Figure 3-25 40 A fuse on MFIO PCB

- 29.1 Remove Upper and Lower Rear Panels.
- 29.2 Remove Footswitch Hook.
- 29.3 Remove 40 A fuse from MFIO PCB (see Figure 3-25).

- 30.1 Remove Upper and Lower Rear Panels.
- 30.2 Remove Footswitch Hook.
- 30.3 Remove 40 A fuse from MFIO PCB (see Figure 3-25).
- 30.4 Remove battery BT1 (CR 2032) from MFIO PCB by pulling clip away from battery, then sliding the battery forward. See Figure 3-26 for battery location.

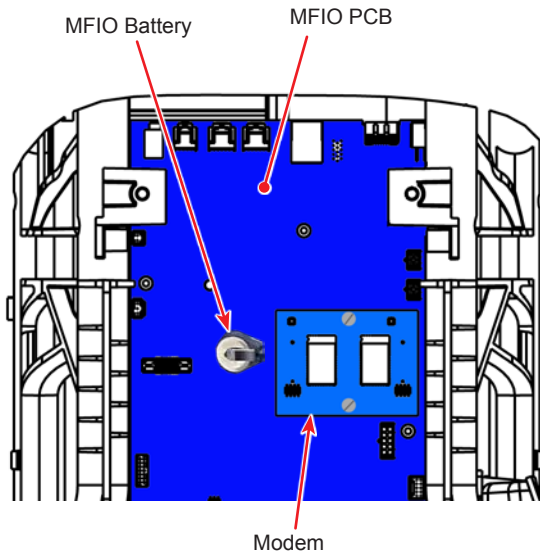
Figure 3-26 MFIO Modem Removal

- 29.4 Disconnect modem connectors J1 and J4.
- 29.5 Carefully remove two standard screws securing Modem PCB to MFIO PCB (see Figure 3-26).
- 29.6 Pull Modem PCB off two connectors on MFIO PCB and remove from console.

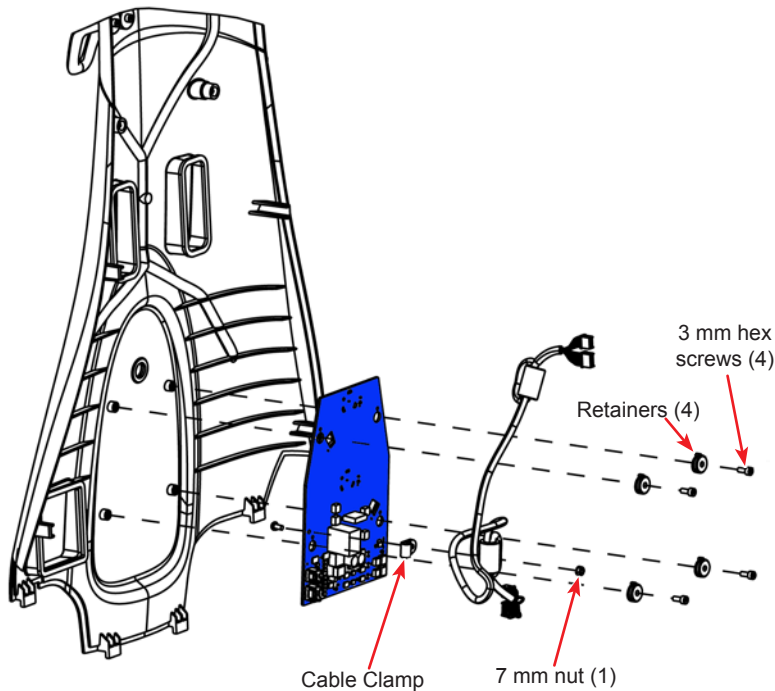
Figure 3-29 Footswitch Charger PCB Removal

- 33.1 Remove Upper and Lower Rear Panel.
- 33.2 Disconnect J1 and J2 from Footswitch Charger PCB.
- 33.3 Remove 7 mm nut and star washer securing cable clamp for W147 to panel.
- 33.4 Remove four 3 mm hex screws and black retainers securing Footswitch Charger PCB to panel.

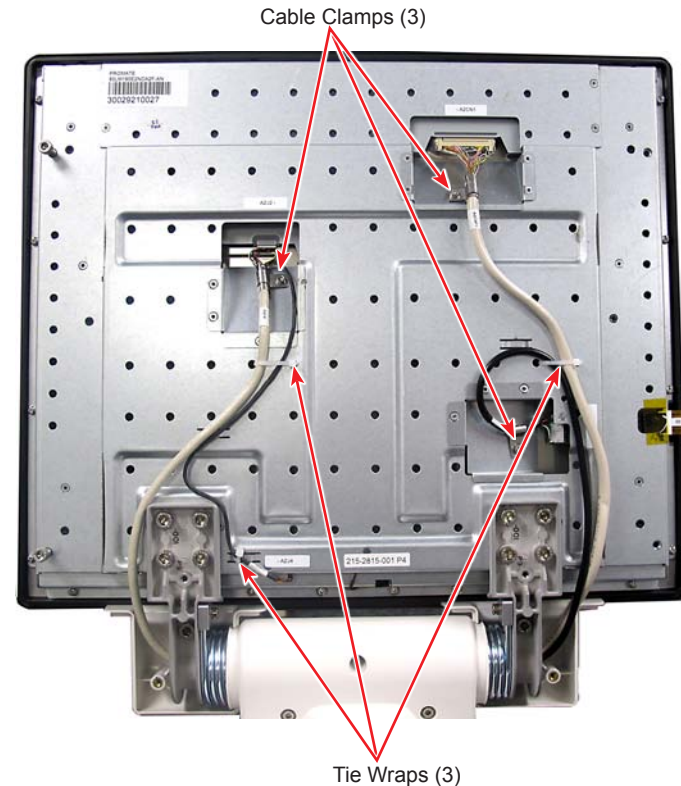
Figure 3-30 Display Cable Routing

- 34.1 Remove Display Wrap Handle and Display Bucket.
- 34.2 Cut three tie wraps securing cables W104, W103, and W126 to Display Assembly (see Figure 3-30).

REPLACEMENT: Note cable routing as shown in Figure 3-30.

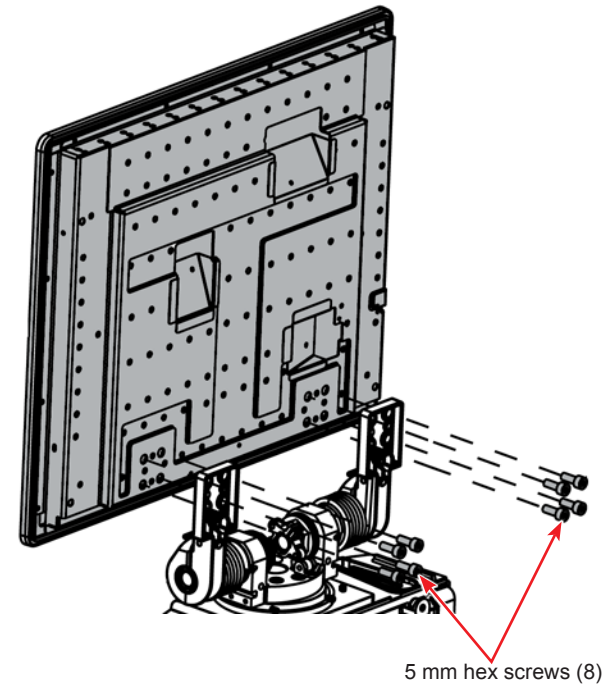
Figure 3-33 Display Removal

- 34.6 Remove eight 5 mm hex screws securing Display Assembly to console (see Figure 3-33). **NOTE: Hinge covers will come off when display is removed.**

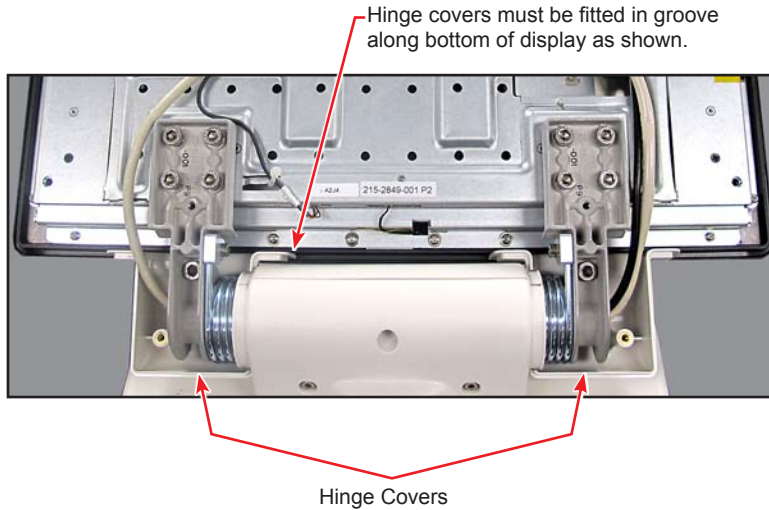
Figure 3-34 Display Hinge Cover Placement

- Install eight 5 mm screws but do not tighten until hinge covers are in position as shown in Figure 3-34.
- Alternately tighten eight 5 mm screws securing Display to hinge.

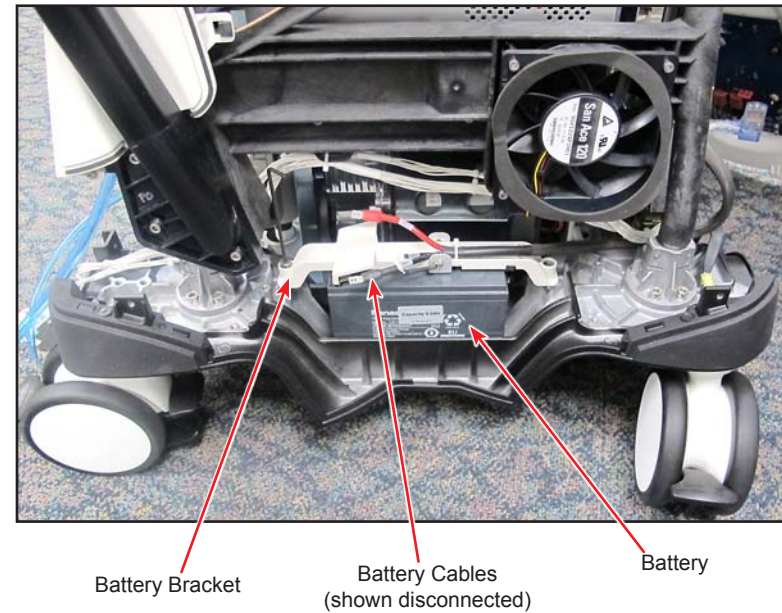
Figure 3-35 Battery Removal

- 35.1 Remove Upper and Lower Rear Panels.
- 35.2 Remove Front Vent, Upper and Lower Front Panels.
- 35.3 Remove Upper and Lower Left Panels.
- 35.4 Remove Upper and Lower Right Panels.
- 35.5 Remove orange 40 A fuse from MFIO PCB.
- 35.6 Disconnect cables from battery (see Figure 3-35).

- 35.7 Remove two 3 mm captive screws securing bracket to chassis.
- 35.8 Move bracket as necessary to gain clearance and remove battery from console.

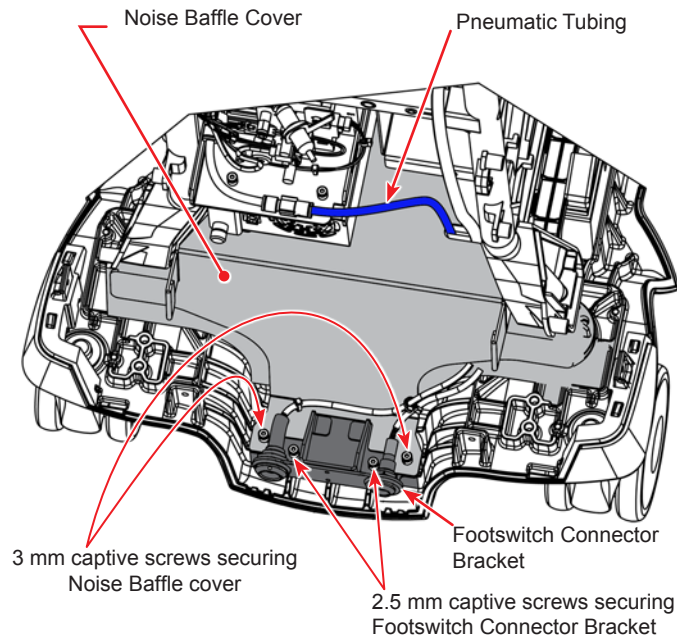
Figure 3-36 Noise Baffle Cover Removal

- 36.1 Remove Upper and Lower Rear Panels.
- 36.2 Remove Front Vent, Upper and Lower Front Panels.
- 36.3 Remove Upper and Lower Left Panels.
- 36.4 Remove Upper and Lower Right Panels.
- 36.5 Remove Front Bumper.
- 36.6 Remove Front Foot Handle Panel.
- 36.7 Disconnect blue pneumatic tubing from Pneumatic Manifold (see Figure 3-36).

- 36.8 Loosen two 2.5 mm captive screws securing footswitch connector bracket to chassis.
- 36.9 Loosen two 3 mm captive screws securing Noise Baffle cover to chassis.

- 36.10 Carefully pull Noise Baffle cover from chassis while adjusting tubing and footswitch connector bracket for clearance. Take care not to damage foam insulation attached to the underside of the Noise Baffle cover.
- 36.11 Remove one 2.5 mm hex screw securing Cassette Drain to chassis (see Figure 3-37). Reposition Cassette Drain to provide clearance for pump removal.

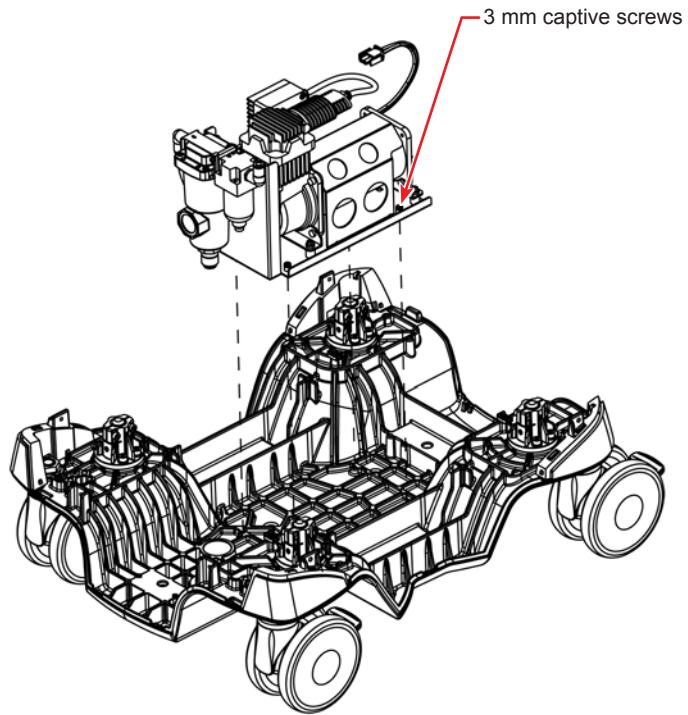
Figure 3-38 **Pneumatic Pump Removal**

- 36.12 Remove both batteries per step 35.
- 36.13 Disconnect Pump Power connection at J4 on MFIO PCB.
- 36.14 Loosen four 3 mm captive screws securing pump to chassis (see Figure 3-38).
- 36.15 Reposition pump as necessary and remove from front of console.

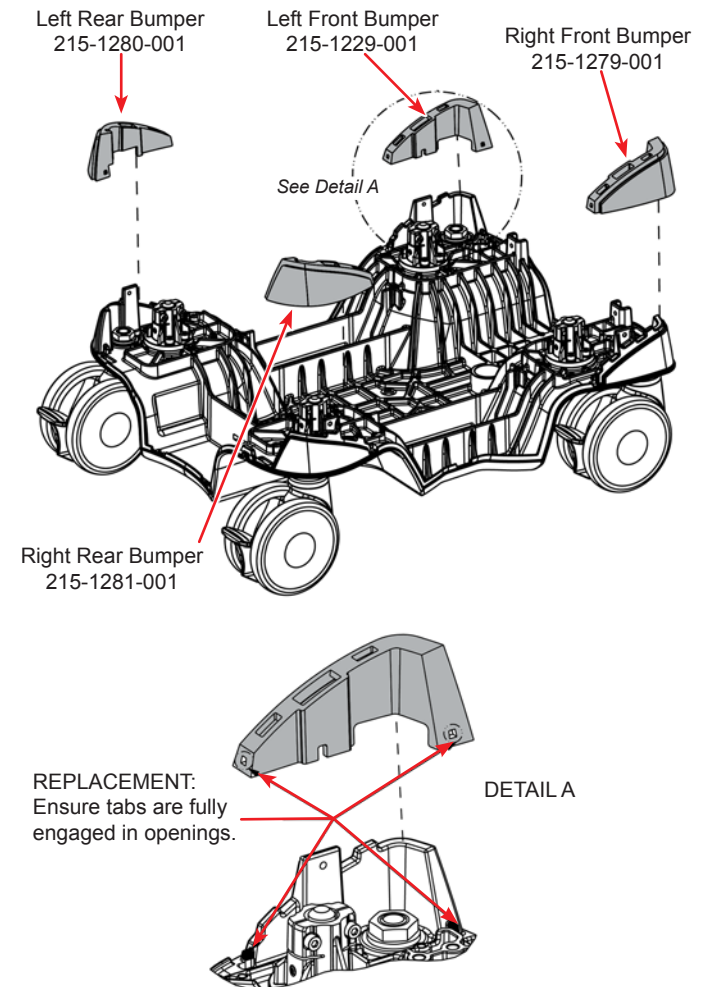
Figure 3-40 Rubber Bumper Removal

- 38.1 Remove panels listed in table below to gain access to bumper to be replaced. Refer to Figure 3-40 for Bumper location.

- 38.2 Pull bumper off tab at each side and remove from chassis.

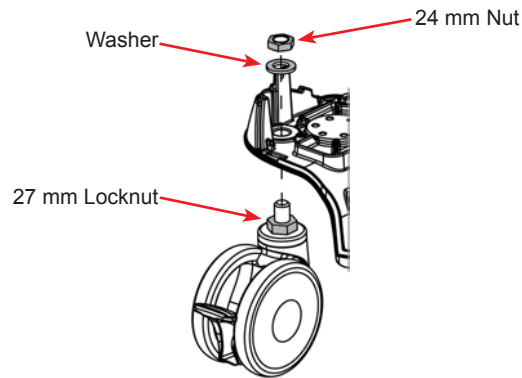
Figure 3-41 Caster Removal

- 39.1 Remove panels as necessary per Table 3-3 to gain access.
- 39.2 Lock casters opposite the caster to be removed.
- 39.3 Lift side with caster to be removed. and place a solid object under the chassis so that there is enough clearance above floor to remove the caster.
- 39.4 While holding the 27 mm locknut in place, remove the 24 mm nut and washer using a deep 24 mm socket wrench (see Figure 3-41).

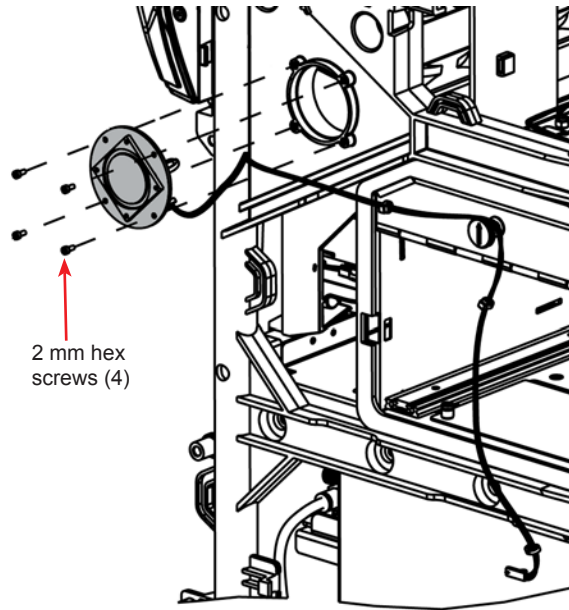
Figure 3-43 Side Speaker Removal

- 41.1 Remove upper and lower rear panels, and upper and lower side panels (left or right as appropriate for speaker to be removed)Si.
- 41.2 Remove four 2 mm hex screws securing speaker/cable assembly to chassis (see Figure 3-43).
